# Automated Traffic Signal Performance Measures

## User Case Examples

UDOT Traffic Operations Center

*PineTop Engineering*

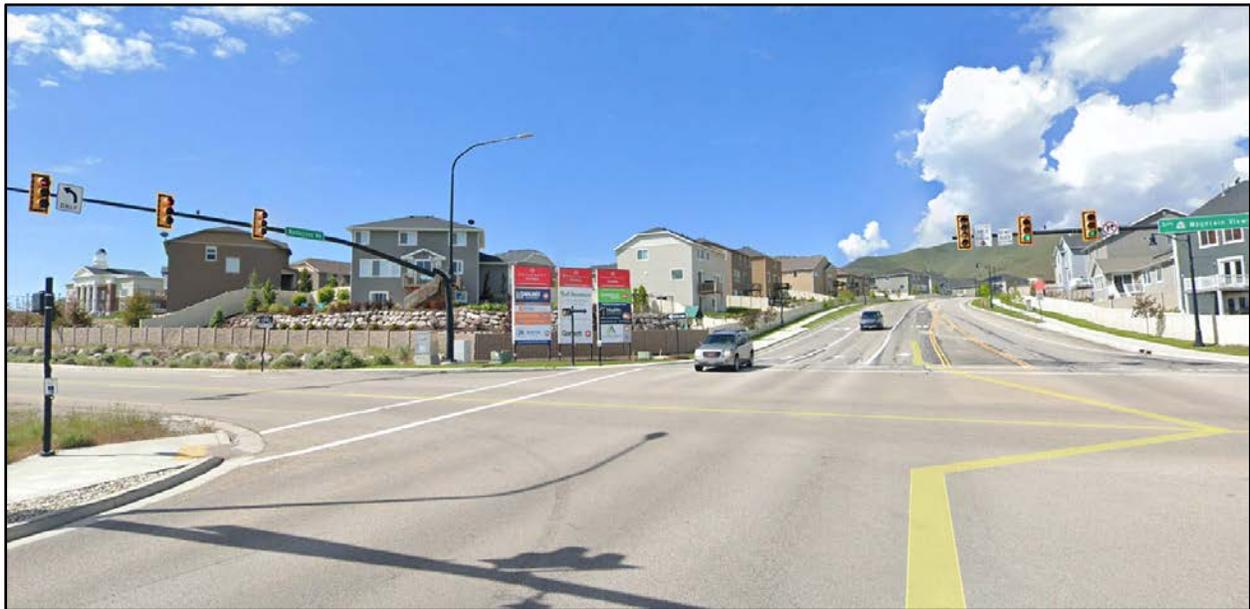
Figure 1.27 Mountain View & Rosecrest Dr - Google Map view looking west

At this signal, a pedestrian was crossing along the south leg crosswalk starting on the southwest corner by the signs and was struck by a vehicle making a westbound to southbound left. Figure 1.27 shows a Google street view of the location. The driver of the vehicle claims that they had a green arrow. The pedestrian stated that the pushbutton was pushed.

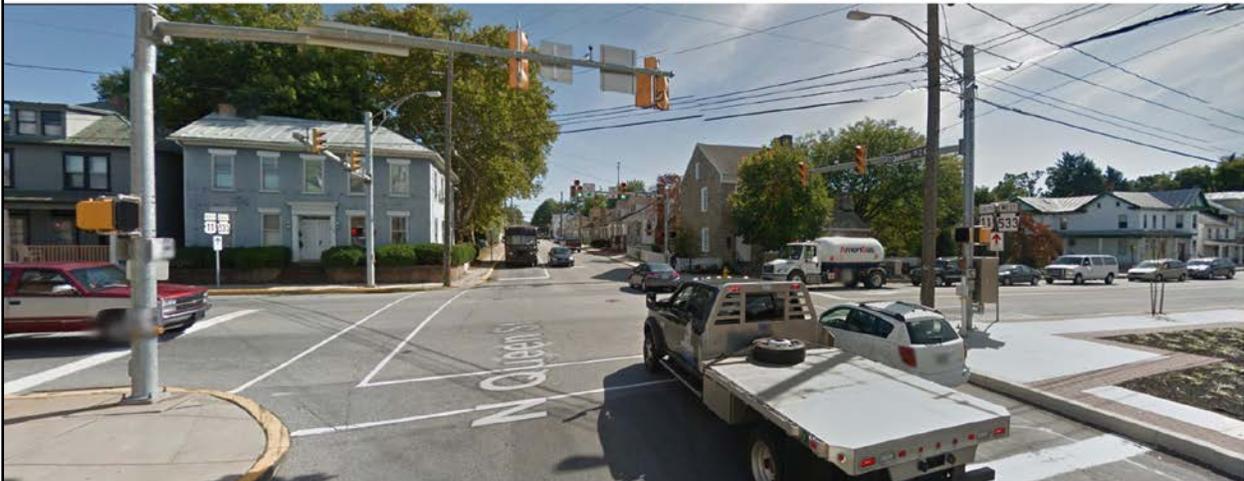
- Shippensburg Borough requested phasing change from lag/lag left turns to lead/lead left turns
- To prevent left turn trap, lagging lefts required terminating both thru phases then serving both lefts, even if only had demand for one left turn

Figure 2.9 Purdue Split Fail Analysis - Sequence Change Potential – PennDOT
